Behavior to a cyclic fracture of an ASTM 316 stainless steel

Pedro G S Passalini^{*a}, Ricardo P Weber^a, Paulo F S Filho^b

^aInstituto Militar de Engenharia (IME)

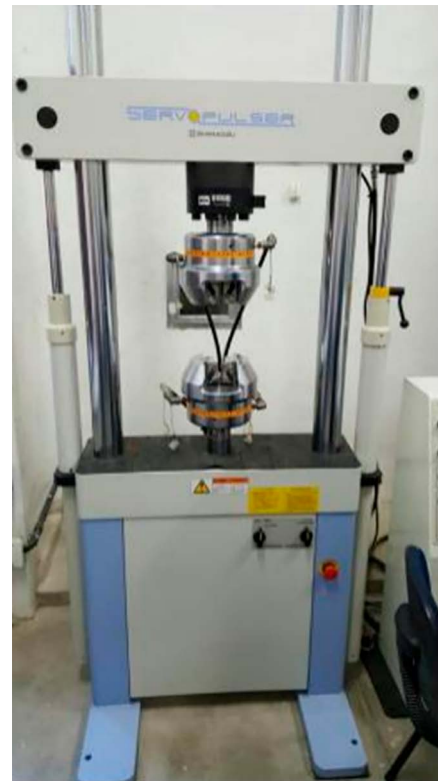
Fig. 2 – Universal test machine used in this study.

The tensile and cyclic tests were performed in a servo-hydraulic machine, Shimadzu Servopulser model (**Figure 2**), with a 5 Mpa pressure in the claws. A Dynastain extensometer was used in the tensile test. The cyclic test was controlled by the maximum and minimum forces of 14kN and -14kN (traction × compression), thus varying the deformation at a frequency of 0.075Hz until rupture.

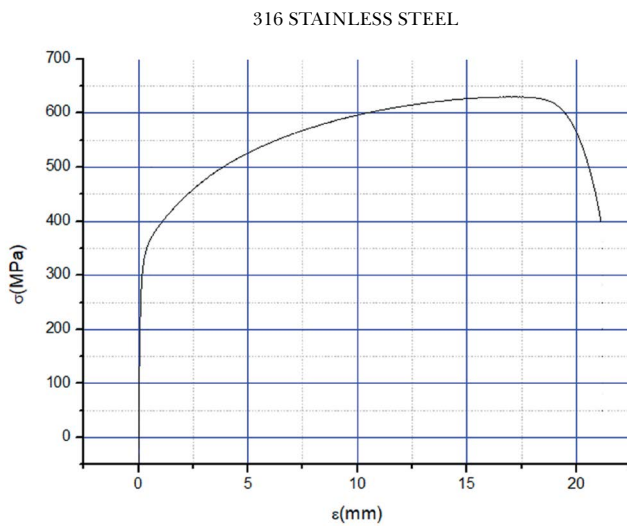
Fig. 3 – Stress × strain curve for a tensile-tested material.

Figure 3 shows the curve obtained by the tensile test. The result expresses the typical behavior of a ductile material [18].

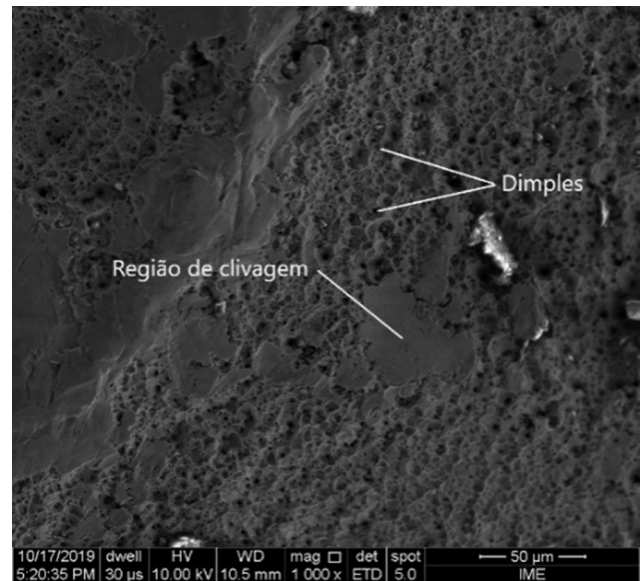
Fig. 5 – Close micrograph obtained by SEM for the fracture of steel in a tensile-tested study.

Figure 4 shows the fracture for the tensile test in which we verified a cup and cone morphology, typical of the ductile fracture [19], with cleavage regions at the edges, which shows that the nucleation of the crack came from the center of the S [20]. In a closer analysis (Figure 5), we identified dimples, which indicate regions of ductile fracture, and cleavage points, which indicate fragile fracture [21]. These points may have been formed by the hardened austenite or by a fraction of the material transformed by the TRIP effect [22].

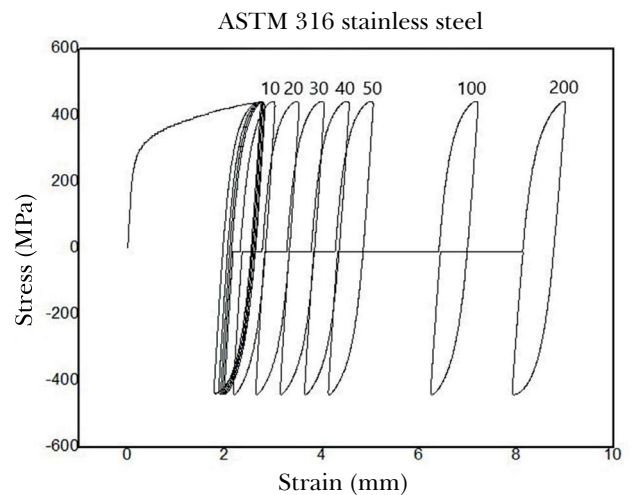
Fig. 6 – Stress × strain curve for the cyclic-tested material (its number is indicated above each formed cycle).

Figure 6 shows the characteristic curve obtained in the cyclic test. We performed the cyclic loading at a stress above the flow stress of the material, which caused it to break with 220 cycles.
